Blast furnace bosh design and repairs

AUTHORS: Reinoud J. van Laar and Frank N. Niemeijer
Danieli Corus

The `Hoogovens` bosh design, comprising plate coolers and highly conductive graphite refractory, has proven to be very robust and able to cope with fierce process conditions, and has achieved lifetimes in excess of fifteen years. Stabilisation of wear is observed after five years, and an almost infinite campaign life can be obtained. The principles behind the design and the operational practices that are observed are explained in this paper.

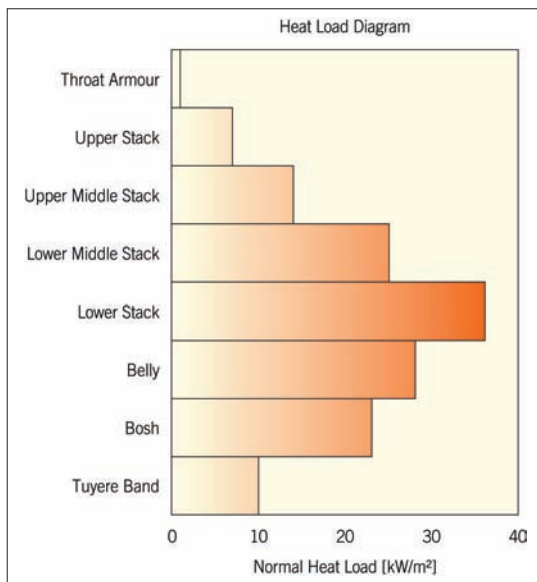
Fig.5 Heat load diagram

The heat load is generated by the internal operations and process conditions which vary irregularly in time and space and is a stochastic variable. A heat load diagram (HLD) is useful to visualise the distribution of the heat load for each zone. A typical profile is illustrated in *figure 5*. Incidental, local heat loads may be 10 times higher, and bosh heat loads > 500,000 W/m² have been recorded in the past. Furthermore, we have noticed that the lower bosh heat loads can also exceed peak belly and lower stack values. This has often

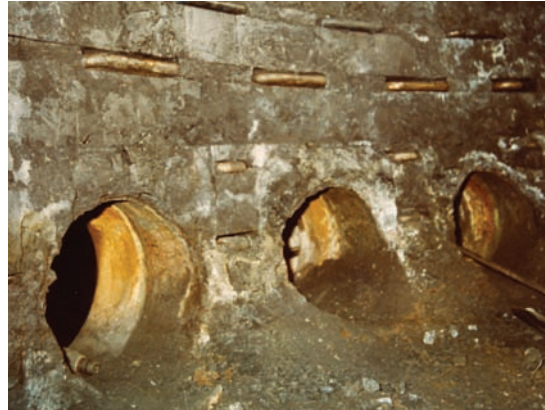
Fig.9 'Hoogovens' IJmuiden No. 4 after 8 years

Figure 9 illustrates the bosh in blast furnace No. 4 after 8 years of operation. The bosh of blast furnace No. 6 was commissioned in 1986 and has been operating at very high productivity levels for many years. One of the principal advantages of a high conductive plate cooler design relates

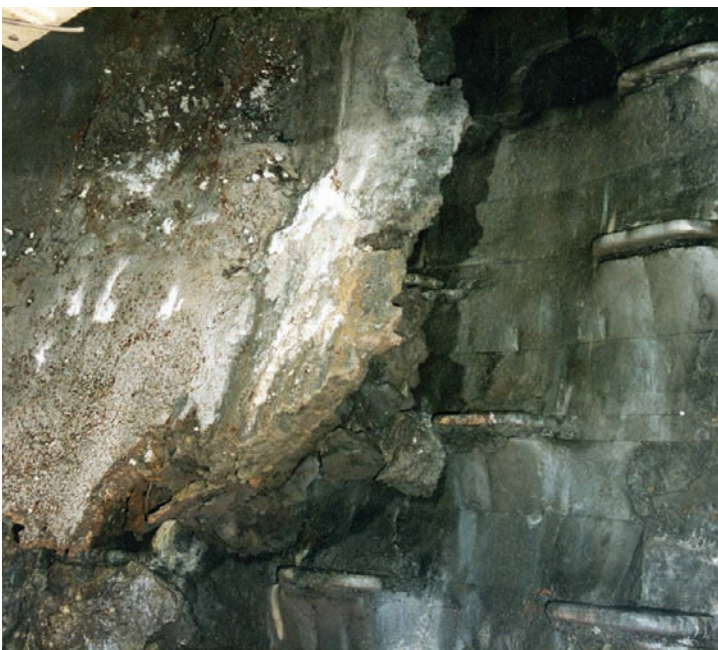
Fig.10 Skull formation

to the 'skull adhesion' capability which this is also clearly observed in *figure 10*.
