Refractory repair strategies for battery life extension

A combination of preventative maintenance and remedial repair strategies, in conjunction with condition monitoring, restores coke oven batteries to proper operational and environmental performance, and leads to life extension.

David Gilroy
Fosbel

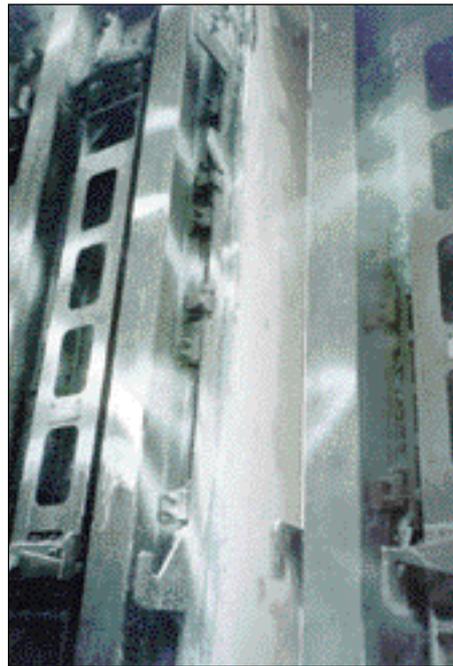
● Figure 1 Oven gunning

Gunning Depending on the age and condition of a battery, gunning is an appropriate repair strategy. It provides a more rapid turnaround than refractory welding for sealing oven walls, especially at the jambs (see Figure 1), and is particularly necessary when specific attention is required to reduce battery emissions after charging, and to meet environmental requirements quickly. Thereafter, a more concerted welding programme is recommended, targeting the worst condition ovens. Gunning does not restore any structural integrity to the wall or jamb; its prime purpose is to seal the oven.

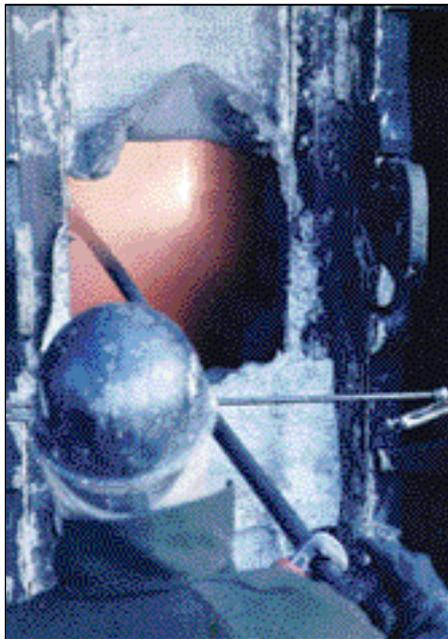
● **Figure 2** Oven welding

Ceramic welding Weld repairs are considered to be the most effective long-term PM repair to coke oven walls, especially for coke side jambs, deep oven cracks, wall undercuts and roof cracks (see *Figure 2*). The oven is required to be out of service for a longer period of time than gunning, which may not meet the exigencies of production or environment. Because of the high temperature coalescence of the weld material and the silica wall, some structural integrity can be restored to the wall when applied by skilled operators. Panel patch repairs using a fused silica Fosbel zero expansion brick (ZEB) and a weld facing is a quick and effective means of patching holes while bonding the repair back to the existing walls.

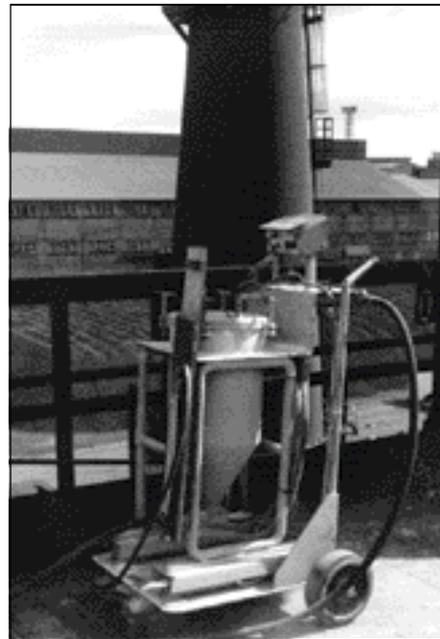
● **Figure 3** Dusting unit

Load cells measure the rate of feed flow into the oven to maintain the dust airborne in order to allow increased residence time in the oven (see *Figure 3*). Oven pressure is an indicator of brickwork condition and pressures are recorded both before and after dusting to establish trends in oven wall sealing. Decay in oven pressure over time is also monitored. Good control over the dusting process is essential to ensure that regenerators are not blocked due to leakage of dust through the wall.

Dusting of ovens Dusting is a process used to seal small hairline cracks in the brickwork of a coke oven chamber. It provides no long-term life extension benefit in itself, but simply enables ovens that have been out of service and lost their wall carbon to return to service without stack emissions on the first few charges. It is carried out on a regular basis on a number of batteries worldwide and the results in terms of maintaining low stack emissions are very

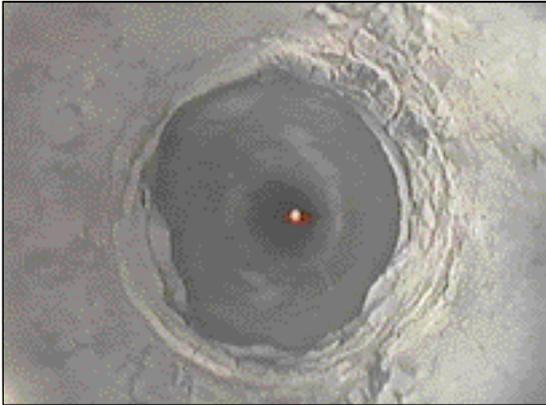
● **Figure 4 Burner riser inspection**

Riser slurring and sleeving Gas risers are slurred to seal cracks between the regenerators and flue ports using a clay-based refractory with a small amount of fluxing agent. Careful control over the amount of material is necessary to ensure flue ports are not blocked, and inspection of the riser (see

Figure 4) can be carried out using a specially designed high temperature inspection endoscope. Additionally, risers are sleeved with (253MA) stainless tubes to minimise gas leakage to the regenerators and flue ports through cracks in the brickwork. The risers are pre-drilled and sleeved to a height appropriate to battery height.

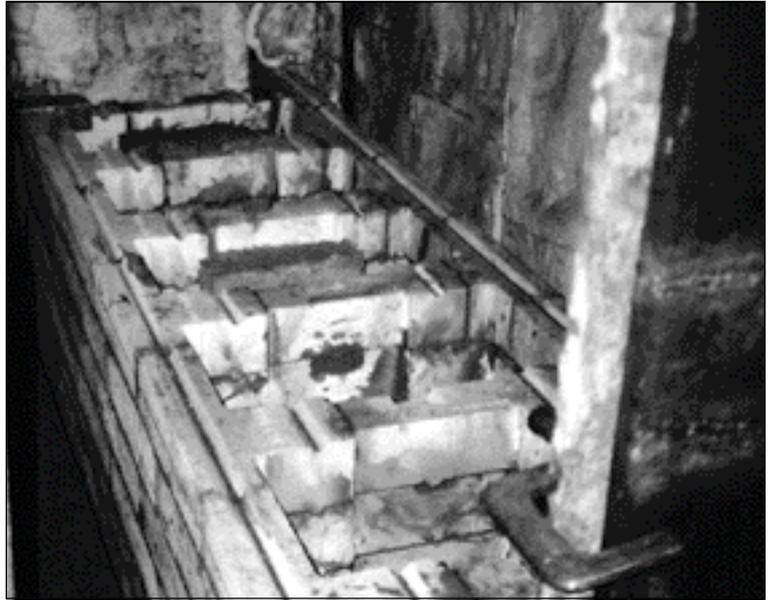
● **Figure 5 MICOWALL brickwork**

MICOWALL (Modular Interlocking Coke Oven WALL) end flues Emphasis is placed on maintaining the heating flues of the adjacent ovens at greater than 1,000°C and the last burning flue of the wall being repaired at greater than 750°C. This is achieved by:

End walls are built tight into hot expanded ovens with no need for complex expansion calculations. No provision is made for expansion between old and new brickwork as the zero expansion characteristics of the new brick mated with existing hot silica has

The use of zero expansion-type products has enabled rapid turnaround in oven repairs with ovens pushed within 24 hours of brickwork completion. For example, the MICOWALL design reduces the number of shapes on a full Wilputte oven wall from over 180 to just 12. These shapes are easily manageable and safer to install due to their reduced weight compared to conventional silica designs, allowing for rapid installation. The original structural and thermodynamic integrity of the oven wall is also maintained with a special interlocking design, especially needed around the horizontal flue.

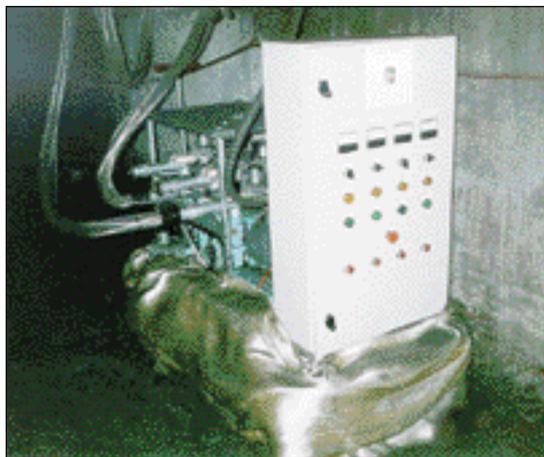
● **Figure 6 Supplementary heater**

- Supplementary heating (LPG) to maintain silica in the sole and regenerator corbels at temperature through burner tubes placed in the regenerators (see Figure 6)
- Heavily insulating the walls with ceramic fibre
- Monitoring closely and responding immediately to the temperature trends in the repair area and use of hot video inspection of the oven walls, gas risers and flue ports to ensure all blockages are removed and heating can be restored

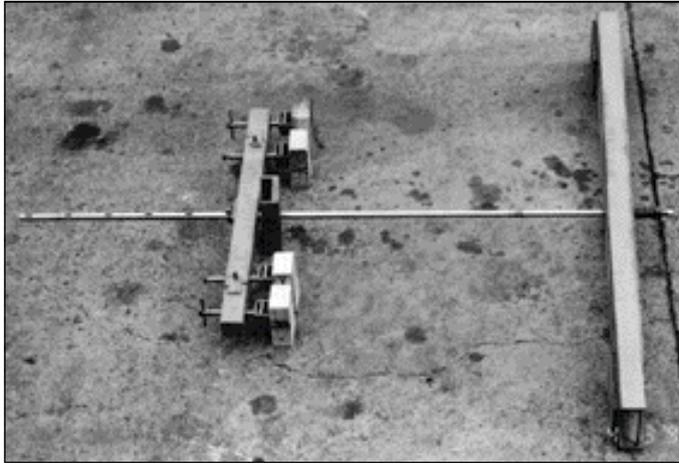
● **Figure 7** Roof support mechanism

The oven roof is usually left in place with MICOWALL rebuilds although the pinion wall roof and oven top usually require removal due to poor condition. Additional design work for the roof support mechanism is required. The concept developed by Fosbel uses a spring-loaded mechanism to counter vibration from moving machinery while maintaining roof support. Unique outriggers are attached to provide additional support of the oven roof blocks (see *Figure 7*).

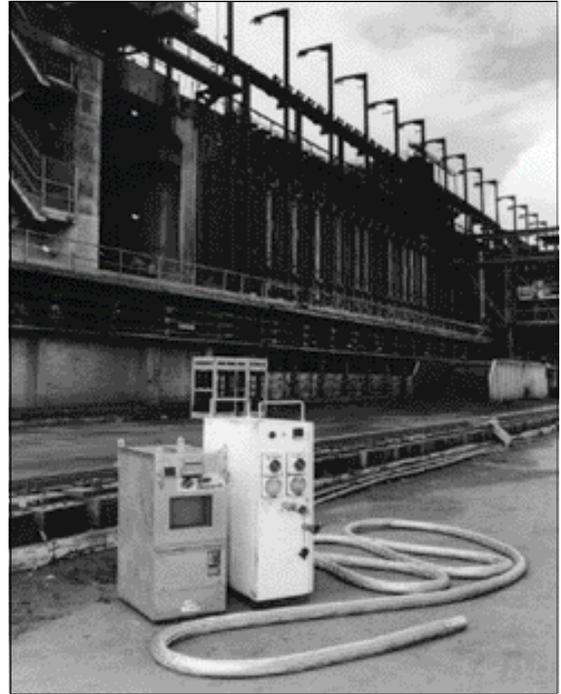
● **Figure 8** Video inspection unit

To ensure that the thermodynamics of the oven are restored, the flue ports are inspected with a high temperature video probe (see *Figure 8*). This unit permits visual inspection of otherwise inaccessible flue ports to ensure that no blockages exist. The probe is a flexible water-cooled 'snake' with a stainless steel jacket (see *Figure 9*) and has been used for hot oven repair inspections, riser pipe inspection and flue port inspections in both oven and regenerator areas of the battery.

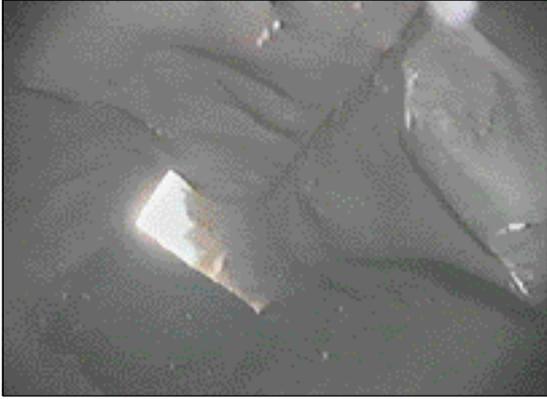
● **Figure 10 Flue port inspection**

Regenerator repairs Prior to any oven wall repair it is essential to ensure that best heating is available to the repaired wall, and so a programme of regenerator checker refurbishment, flue video inspection (see *Figure 10*) and chamber wall and corbel repair is carried out. This is coupled with stainless steel sleeving to refurbish risers and includes the repacking of coke side and pusher side regenerator chambers in Wilputte batteries and up to four flues on Otto Simon Carves batteries. (Repacking up to 4 flues on Otto batteries provides 90% of the solution to damaged or blocked ports.) The objective is to maintain the regenerator, corbels and oven sole silica brick in a hot condition (>750°C) through insulation (see *Figure 11*) and/or supplementary heating.
